Civil Engineering Services Report For

Development at St. Johns Convent, Rathangan

| Client | Sophic | Sophia Housing Association | | | | | | |
|---|---|---|---|---|---|---|---|---|
| Document Title | le Planning Report | | | | | | | |
| Document No. | 20D004-PR 01 | | | | | | | |

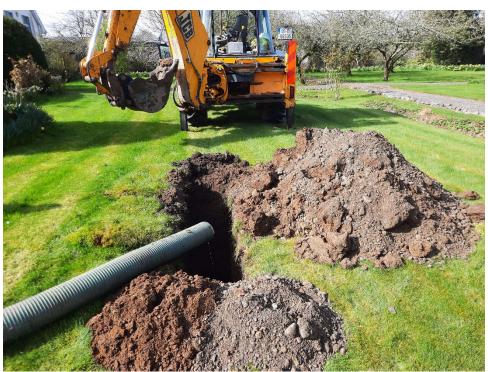
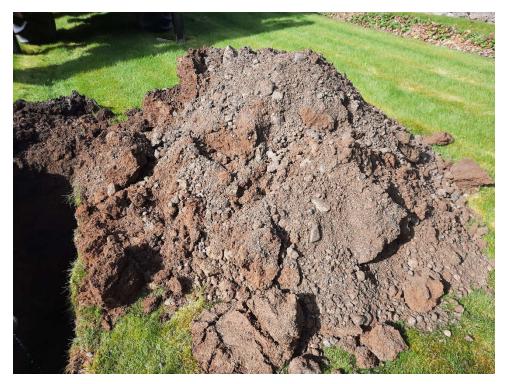
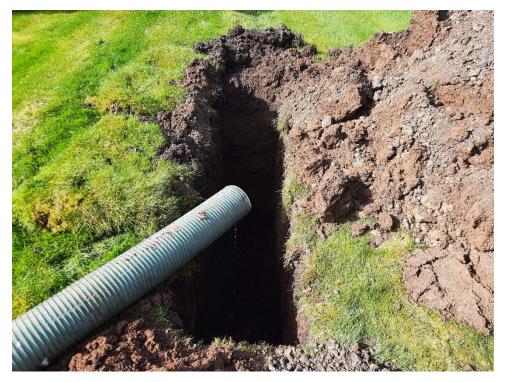
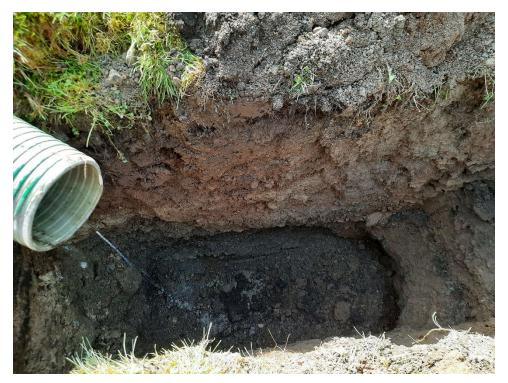
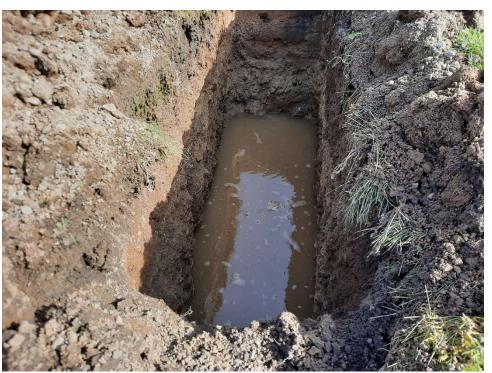
St. John's Convent, Rathangan – Soakaway Test Photographs

The soakaway testing was carried out in a selected trial pit at the location shown in the exploratory hole location plan in Appendix 1. This pit was carefully excavated and filled with water to assess the infiltration characteristics of the proposed site. The pit was allowed to drain and the drop in water level was recorded over time as required by BRE Digest 365. The pit was logged prior to completing the soakaway test and were backfilled with arising's upon completion. The soakaway test result is provided in Appendix 4 of this Report.

An infiltration rate of $f = 7.32 \times 10^{-6}$ m/s was calculated for the soakaway location SA01.

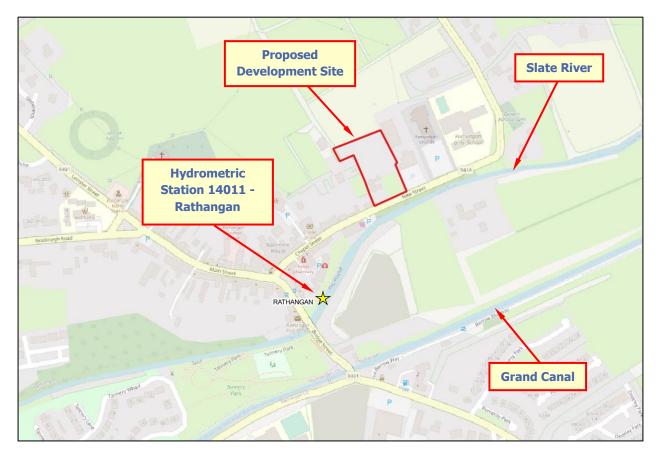
Figure 2 - Hydrometric Gauging Station

Existing sources of OPW, EPA and local authority hydrometric data were investigated. As illustrated in *Figure 3* below, this assessment has determined there is one hydrometric gauging station located in the general vicinity of the proposed development site.

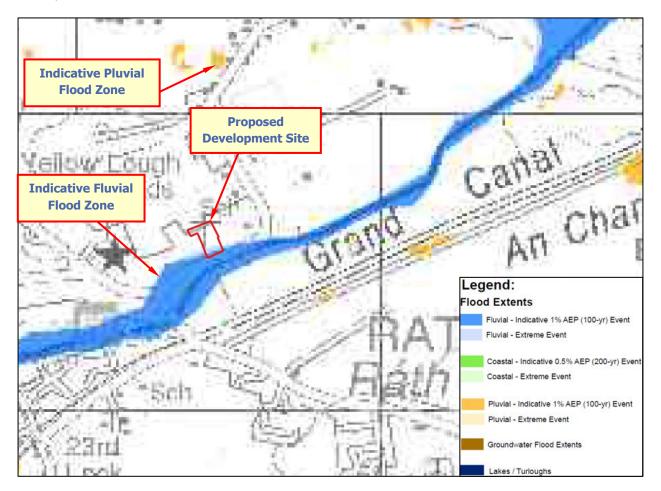
Figure 3 - OPW PFRA Mapping

Preliminary Flood Risk Assessment (PFRA) Mapping for Ireland was produced by the OPW in 2011. OPW PFRA flood map number 2019/MAP/218/A illustrates indicative flood zones within this area of County Kildare.

Figure 3 below illustrates an extract from the above indicative flood map in the vicinity of the proposed development site.

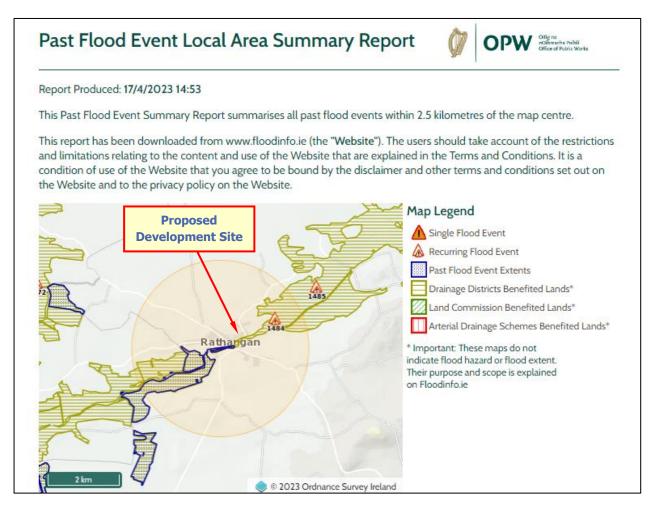
Figure 4 - OPW Flood Info Records

Figure 4 above indicates that there is one recorded recurring flood event located approximately 1.1km upstream of the proposed development site (Flood ID = 1484). The OPW meeting minutes indicate that

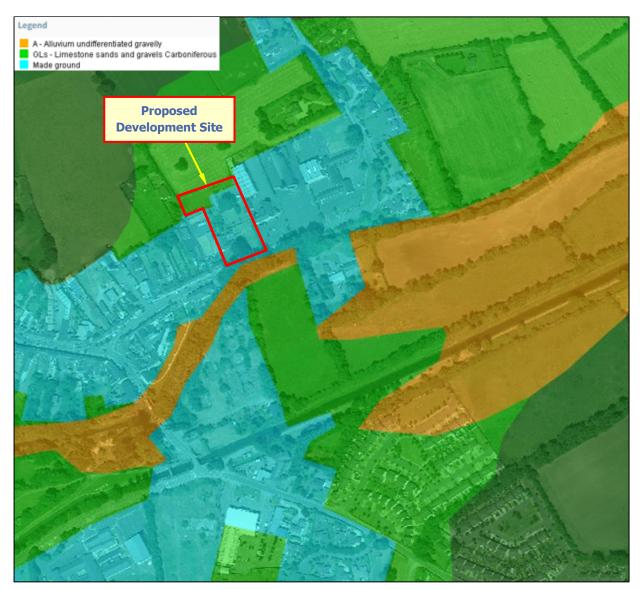
Figure 7 - GSI Subsoil Mapping

The alluvial deposit maps of the Geological Survey of Ireland (GSI) were consulted to assess the extent of any alluvial deposits in the vicinity of the proposed development site. Alluvial deposits can be an indicator of areas that have been subject to flooding in the recent geological past.

Figure 7 below illustrates the sub-soils mapping for the general area of the site.

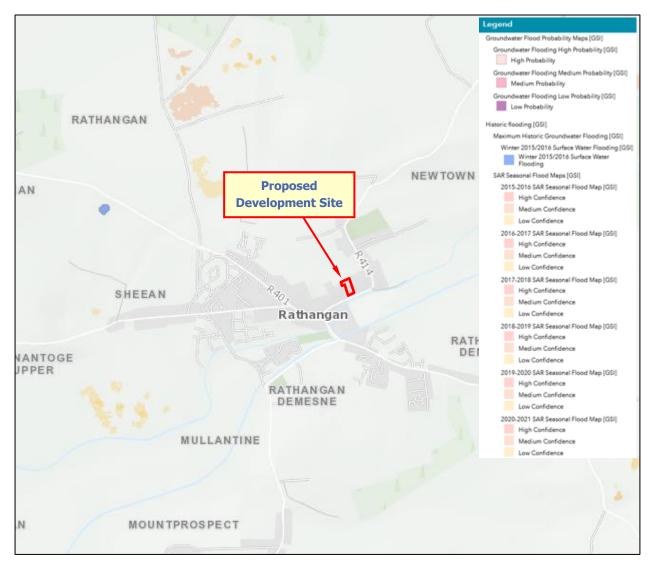
Figure 8 - GSI Groundwater Flood Mapping

Figure 8 below illustrates an extract from the above groundwater flood mapping in the vicinity of the site.

The above GSi Groundwater Mapping indicates no areas of predictive or historical groundwater or surface water flooding located at or in the vicinity of the site.

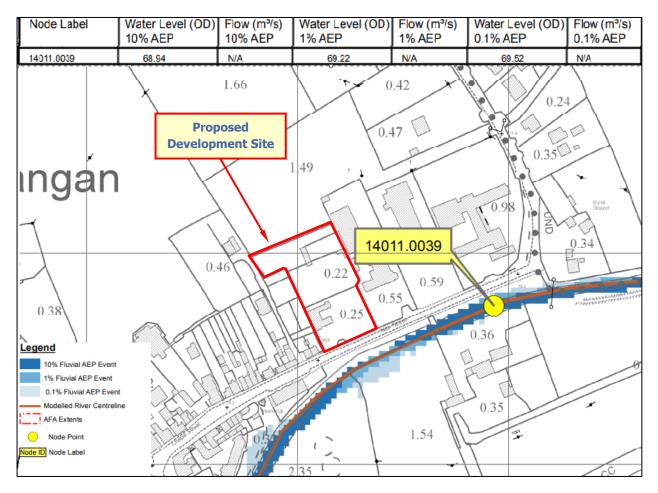
Figure 9 – CFRAMS Fluvial Flood Maps

Figure 9 below (extracted from CFRAMS flood maps O14RTN_EXFCD_F0_03) illustrates the predictive extreme present day scenario 10% AEP (1 in 10 year), 1% AEP (1 in 100 year) or 0.1% AEP (1 in 1000 year) flood extents in the vicinity of the site.

As illustrated in *Figure 9* above, the site of the proposed development does not fall within a predictive present day scenario 10% AEP (1 in 10 year), 1% AEP (1 in 100 year) or 0.1% AEP (1 in 1000 year) fluvial flood zone.

A full copy of OPW CFRAMS flood extent map O14RTN_EXFCD_F0_03 is presented in Appendix B.

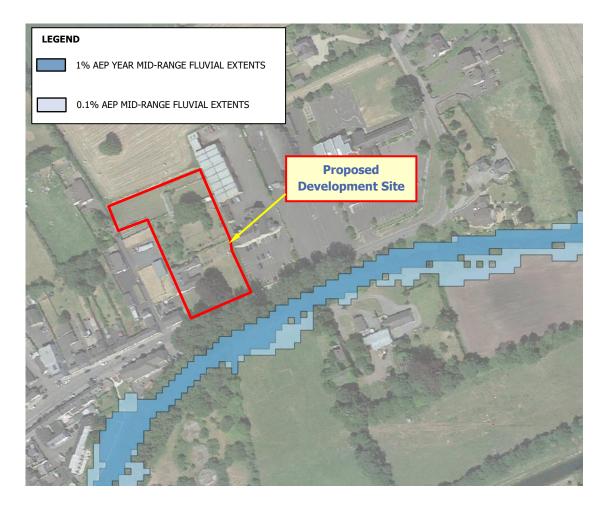
Figure 10 – OPW CFRAMS Flood Extents – Mid-Range Future Climate Change Scenario

Figure 10 below illustrates the predictive mid-range future climate change scenario 1% AEP + CC (1 in 100 year + climate change) and 0.1% AEP + CC (1 in 1000 year + climate change) OPW CFRAMS fluvial flood extents at the location of the proposed development site.

As illustrated in *Figure 10* above the proposed development site does not fall within a predictive midrange future climate change scenario 1% AEP + CC (1 in 100 year + climate change) or a 0.1% AEP + CC (1 in 1000 year + climate change) fluvial flood zone.

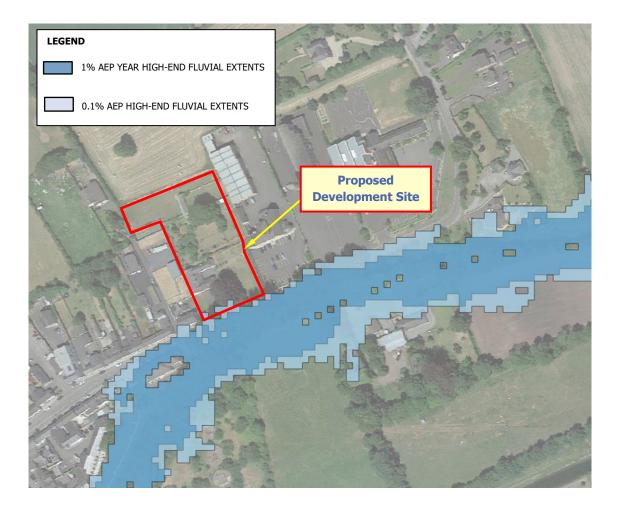
Figure 11 – OPW CFRAMS Flood Extents – High-End Future Climate Change Scenario

Figure 11 below illustrates the predictive high-end future climate change scenario 1% AEP (1 in 100 year) and 0.1% AEP (1 in 1000 year) OPW CFRAMS fluvial flood extents at the location of the proposed development site.

As illustrated in *Figure 11* above the proposed development site does not fall within a predictive high-end future climate change scenario 1% AEP + CC (1 in 100 year + climate change). The predictive high-end future climate change scenario 0.1% AEP + CC (1 in 1000 year + climate change) flood extent slightly encroaches the southern boundary of the site, however no residential development is proposed as this particular location, this area of the site shall be public open space only.

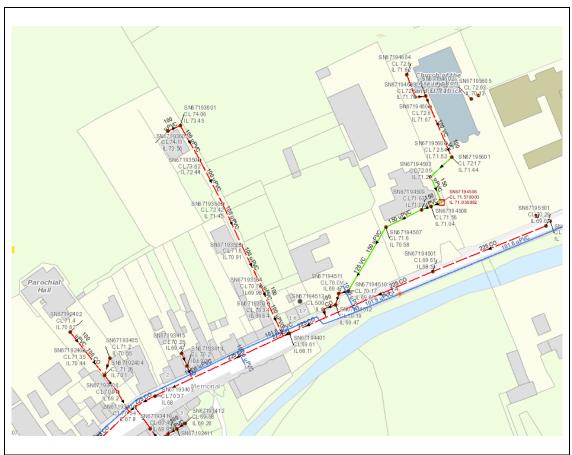
The map included below outlines the current Uisce Éireann infrastructure adjacent the Development: To access Uisce Éireann Maps email datarequests@water.ie
