HISTORIC BUILDING APPRAISAL

APPRAISAL OF HISTORIC RUINS

Sallins Amenity Lands, Osberstown, Co. Kildare

February 2021

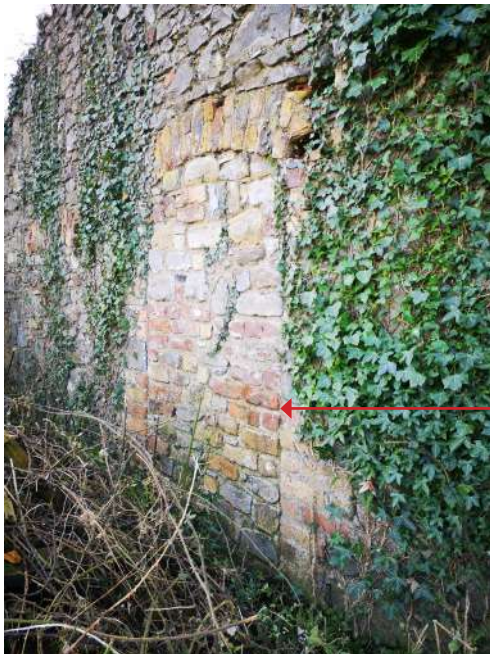
Original brick reveals evident to each side of opening

View of central blockwork arched doorway to north-west ruin

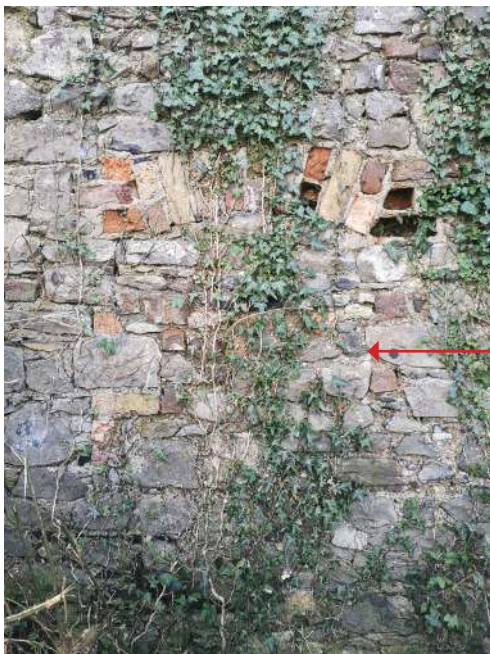
No brickwork reveals evident externally - archway expressed internally as recessed arch

View of blocked archway to east of central arch

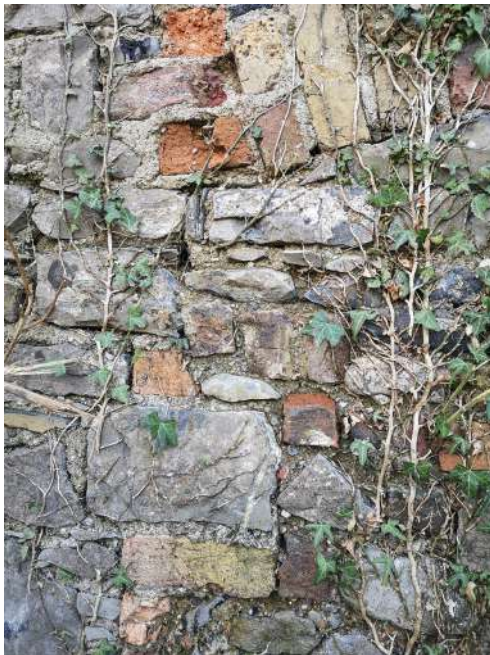
No brick reveal evident to arched window

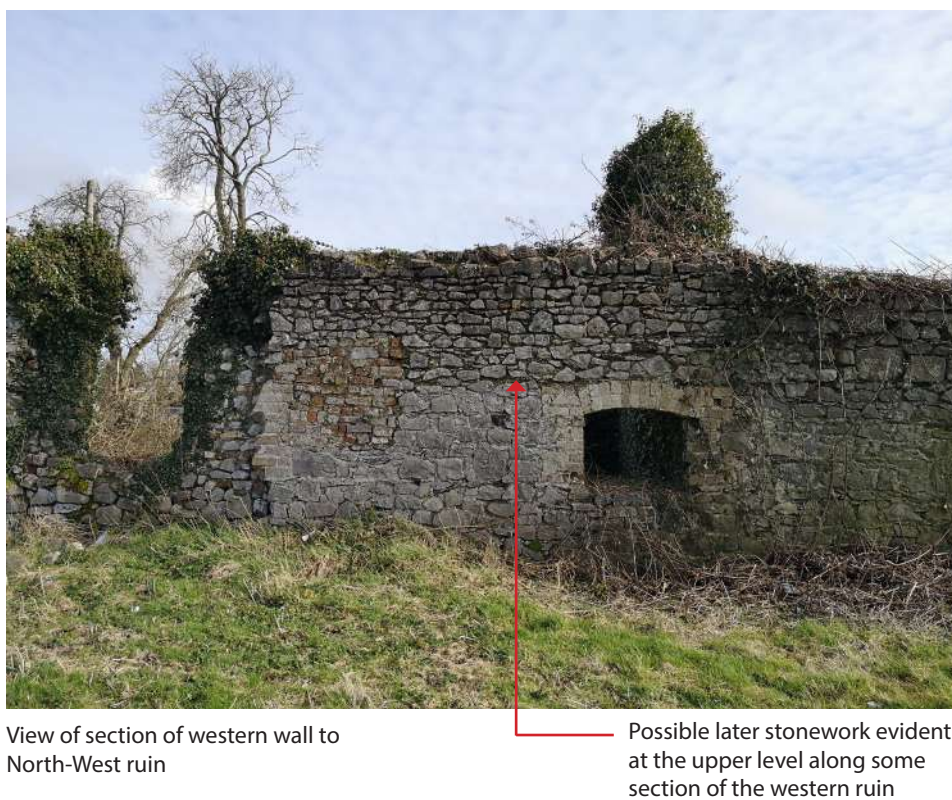
Possible later stonework evident at the upper level along some section of the western ruin

External inspection of the stonework to the western wall of this out-building, shows possibly two stages of construction, defined clearly by a horizontal line, where larger stonework is evident to the lower section of this wall and smaller stones have been used above the window arch level. This may indicate that the above sections were later repairs and consolidation works. Some of the top wall of this western wall may have been demolished in the construction of the steel agricultural shed, where a line of blockwork has replaced same.

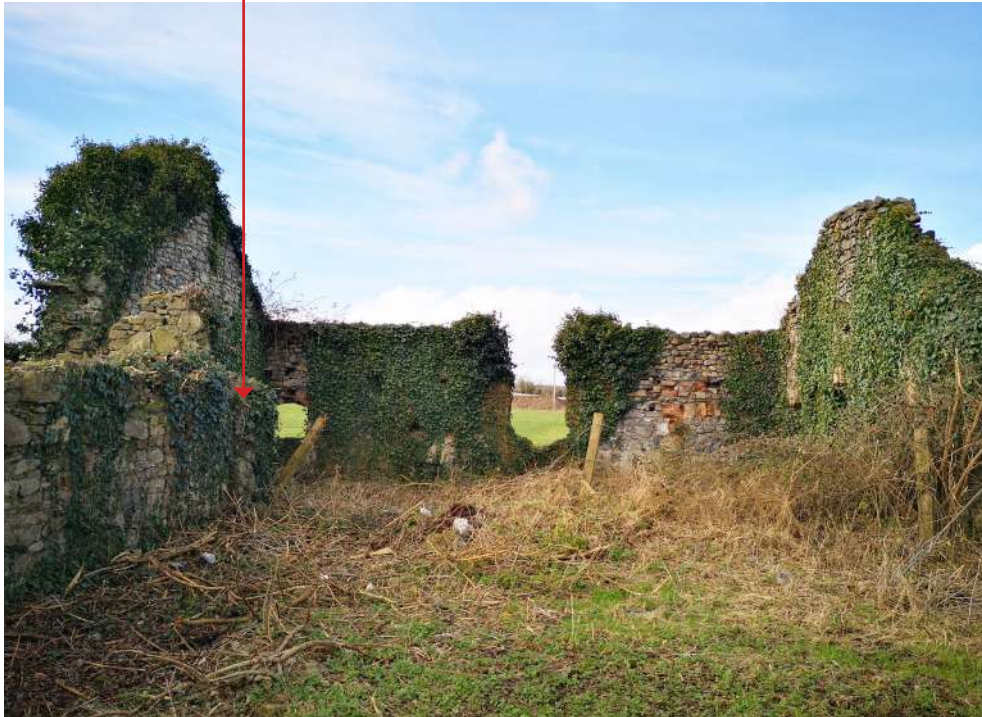
View of ruin to the North-West from east

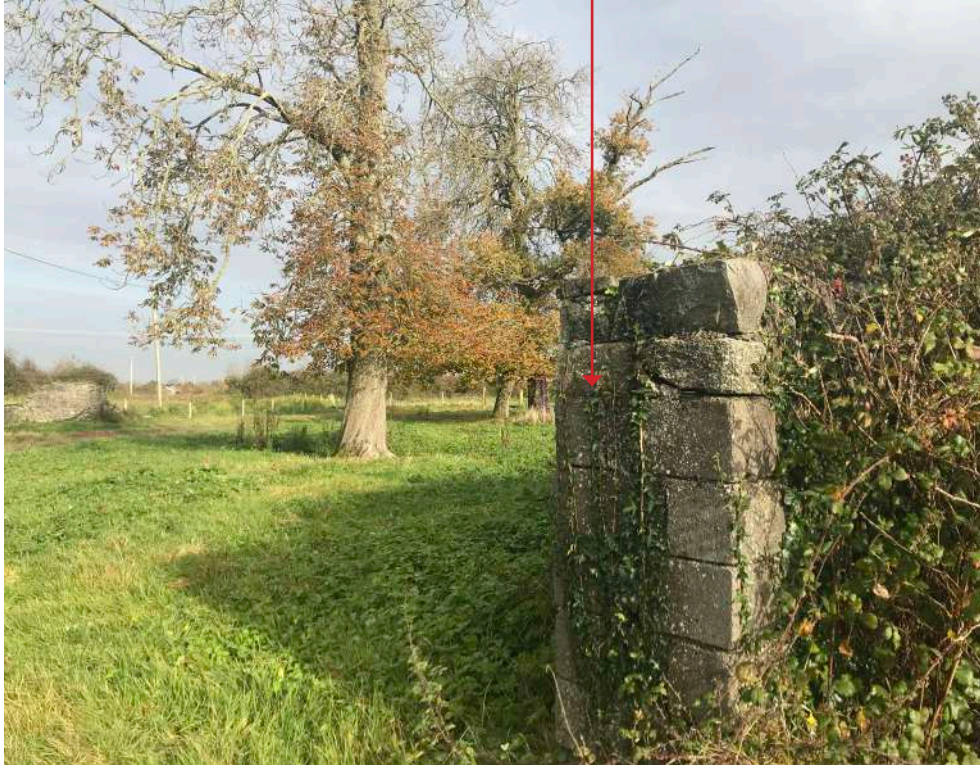
Opening to courtyards dividing wall

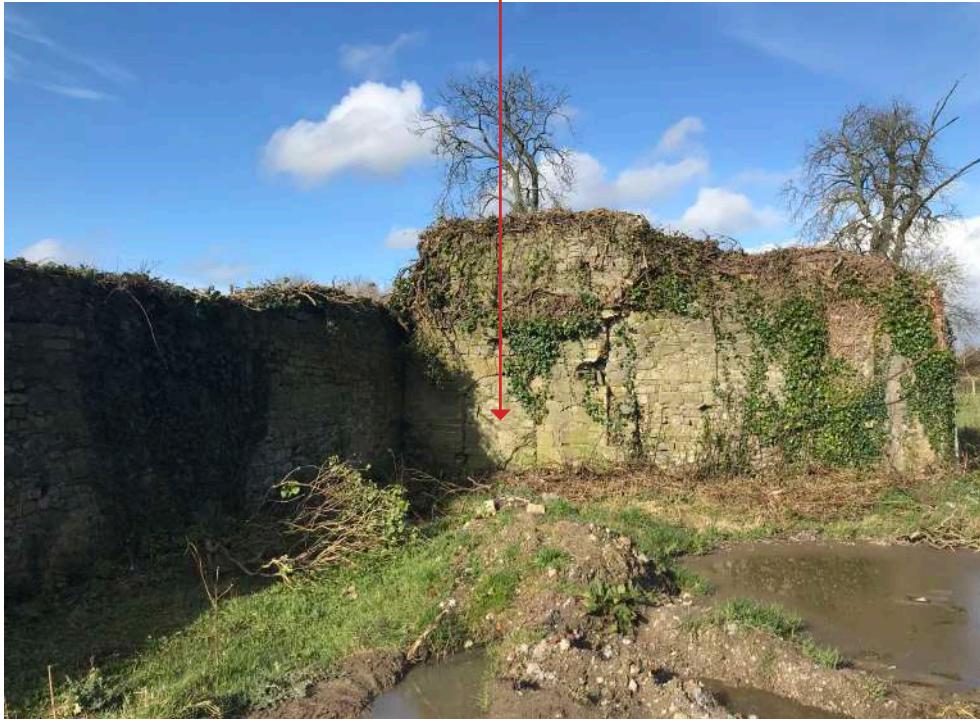
View of remaining bagle to eastern ruin

Larger blocked opening evident

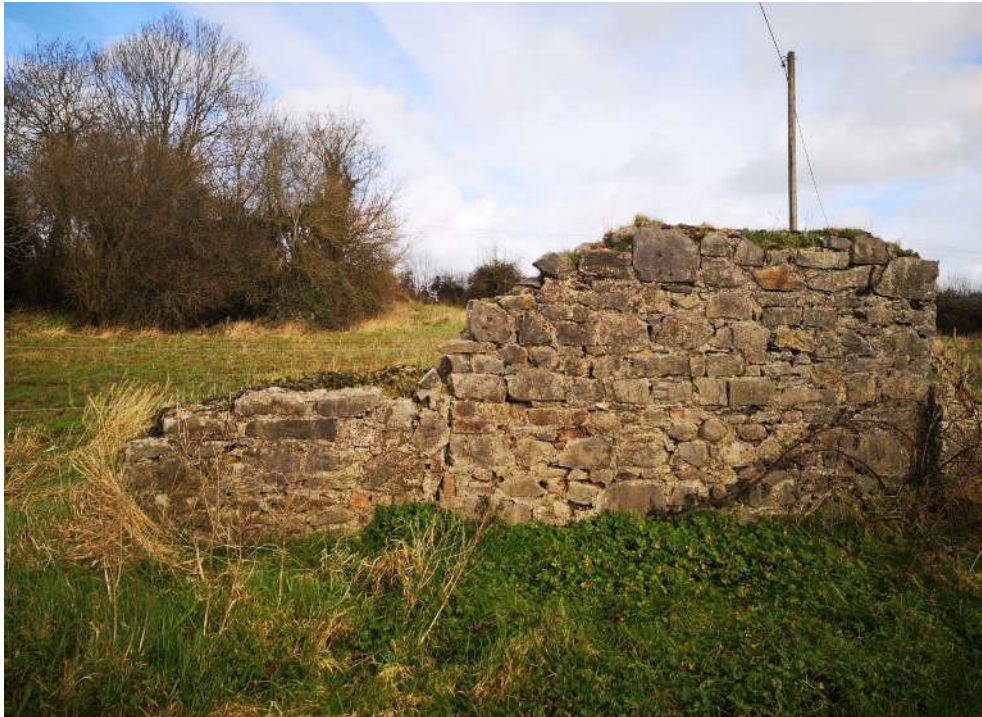
No original lime render evident to exposed stonework

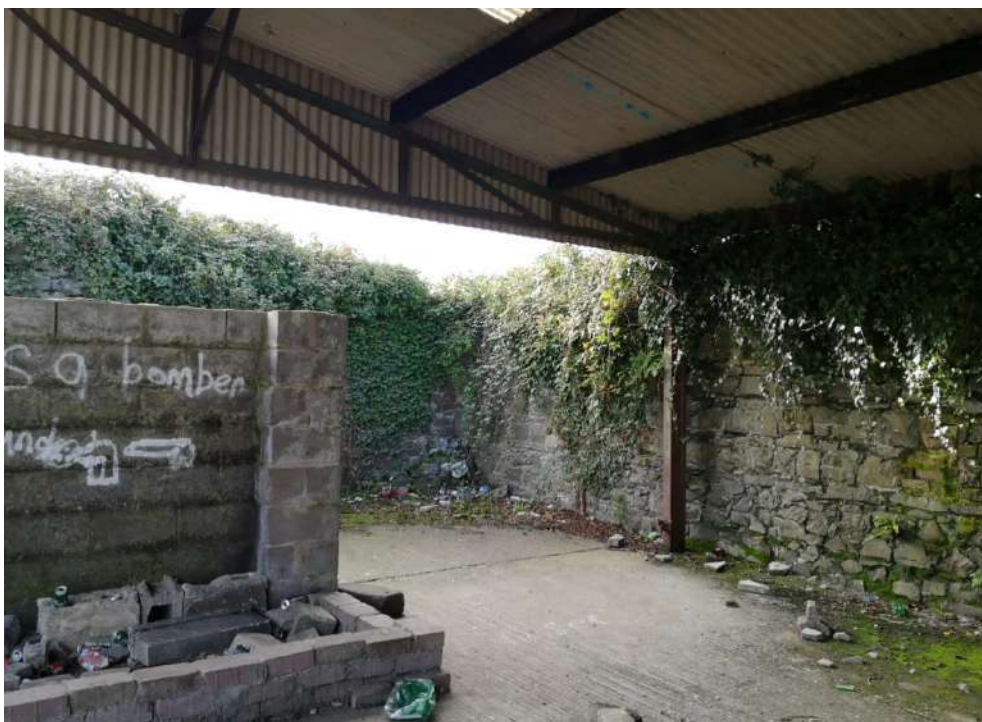
View of South-Western corner of rear courtyard and later agricultural sheds

Concrete blockwork wall divisions within later agricultural shed structures

Concrete floor to agricultural shed area
