Chief Executive's Report

For proposed Tree Preservation Order (TPO) in Caragh,
Naas, Co. Kildare

Planning Department,
Kildare County Council
14th July 2022

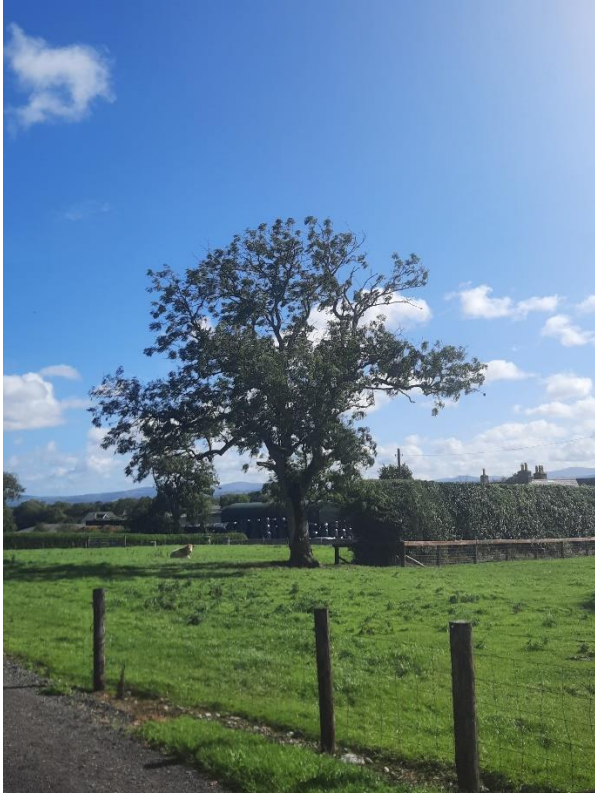
- Tree No. 9 is a *Fagus sylvatica* (Beech tree) and has significant damage to its buttress and lower trunk. The wound is approximately 2 metres high and 1.5 metres wide, with decay in the centre.
- Tree Nos. 19 and 20 are a *Fraxinus excelsior* (Ash trees) which show signs of Ash Dieback.

Figure 8: Single tree (No. 20 on Map) subject of proposed TPO

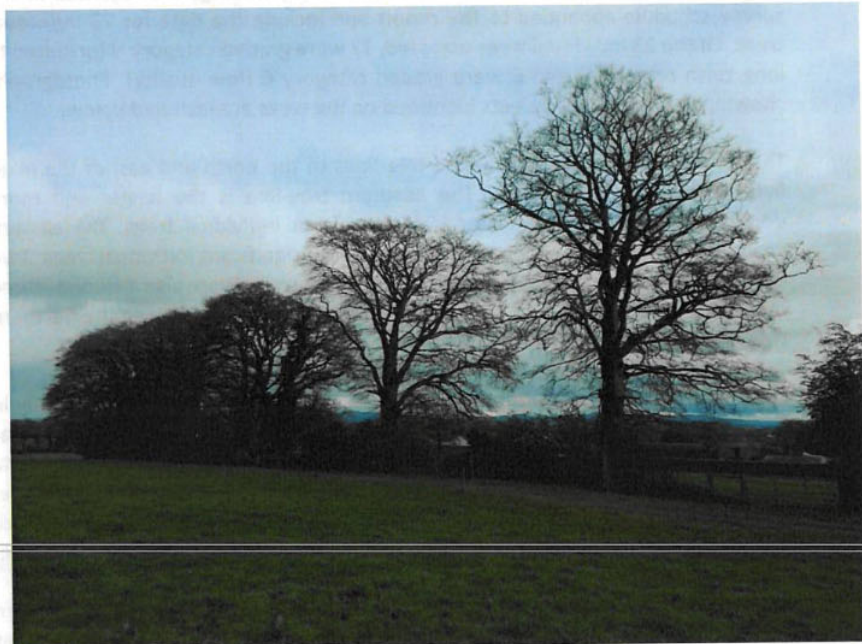
Longer tree-line along northern edge of site (trees 1-15)

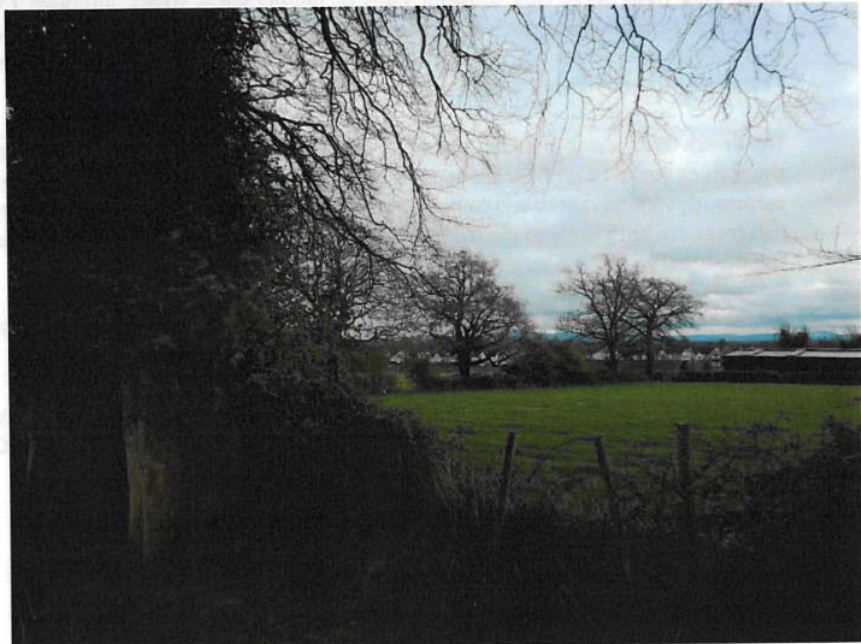
Final trees included in preliminary schedule in background (trees 18-21)

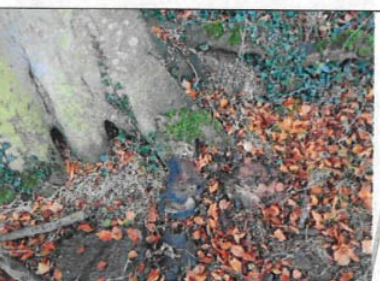
<p>Beech stump S3</p>	<p><i>Meripilus giganteus</i> fungal fruiting bodies on Beech tree T8</p>

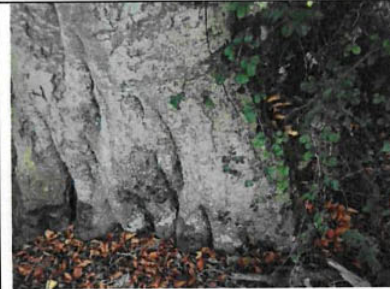
Armillaria spp. fungi at base of Beech tree T13

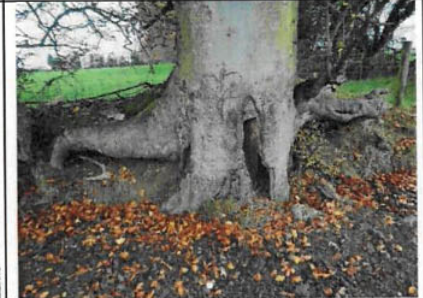
Base of Beech tree T16

T	16	Fagus sylvatica (Beech)	OM	20	1000	<10	Poor	Poor. Significant basal decay.	Not suited for long-term retention.	12	U
T	17	Fagus sylvatica (Beech)	M	21	1250	10+	Fair	Fair. Large specimen tree.	Monitor tree condition.	15	C2
T	18	Fagus sylvatica (Beech)	OM	21	1000	<10	Poor	Poor. Old tear-out wound on main stem. <i>Meripilus giganteus</i> fruiting brackets at stem base indicating degraded anchorage and stability. Sparse crown.	Not suited for long-term retention.	12	U
T	19	Quercus robur (Common Oak)	M	18	850	10+	Poor	Fair. Some dieback of upper crown.	Monitor tree condition.	10.2	C2
T	20	Quercus robur (Common Oak)	M	18	850	10+	Poor/Fair	Fair. Some minor dieback of upper crown.	Monitor tree condition.	10.2	C2
T	21	Fagus sylvatica (Beech)	OM	21	1250	<10	Poor	Poor. Dieback in crown. <i>Ganoderma</i> spp. fruiting brackets on lower stem indicative of significant basal decay.	Not suited for long-term retention.	15	U

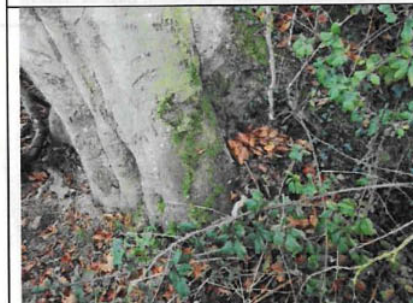
Meripilus giganteus fruiting bodies on Beech T18

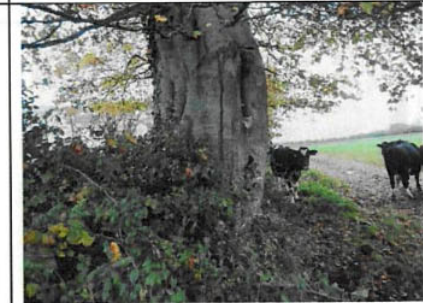
Ganoderma spp. fungi on stem of tree T21

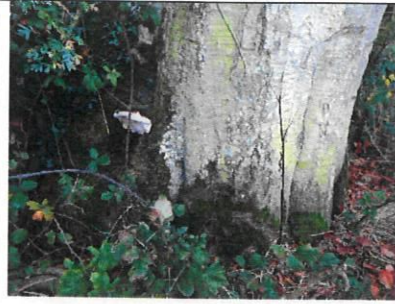
Ganoderma spp. fungi at base of tree T1

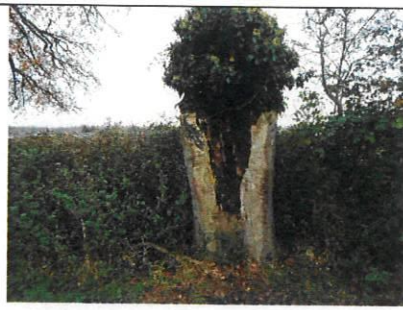
Beech stump S1

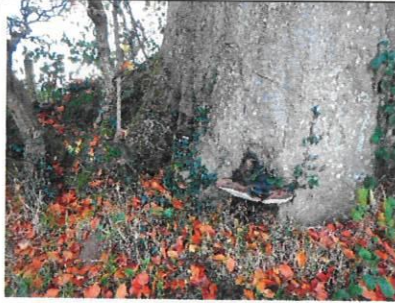
Ganoderma spp. fungi at base of tree T2

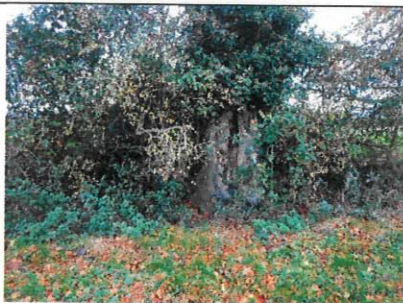
Beech stump S2

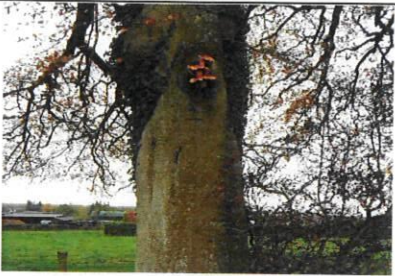
Fungal fruiting bodies on Beech tree T4

T	4	Fagus sylvatica (Beech)	OM	21	1000	<10	Poor	Poor. Large decay cavity on stem. Fungal fruiting bodies emerging from cavity on main stem. Some sparseness of upper crown.	Not suited for long-term retention within a new development.	12	U
T	5	Fagus sylvatica (Beech)	OM	21	1000	<10	Fair/Poor	Poor. <i>Ustulina deusta</i> fruiting bodies present at stem base indicating embrittled heartwood in stem.	Not suited for long-term retention within a new development.	12	U
S	3	Fagus sylvatica (Beech)	OM					Stump of old Beech tree that has collapsed due to basal decay.	No urgent works needed.		
T	6	Fagus sylvatica (Beech)	OM	21	1000	<10	Fair/Poor	Poor. <i>Ustulina deusta</i> fruiting bodies present at stem base indicating embrittled heartwood in stem.	Not suited for long-term retention within a new development.	12	U
T	7	Fagus sylvatica (Beech)	M	21	1000	10+	Fair/Poor	Fair. Low vitality.	No urgent works needed.	12	C2

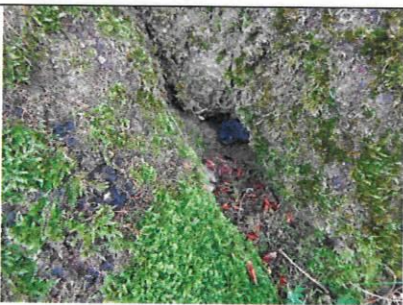
Ustulina deusta fruiting bodies at base of tree T5

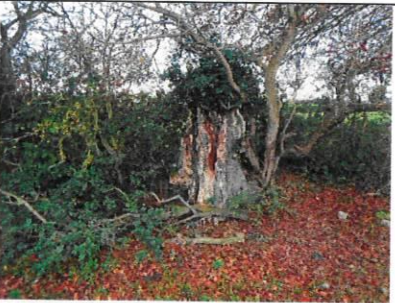
Beech stump S3

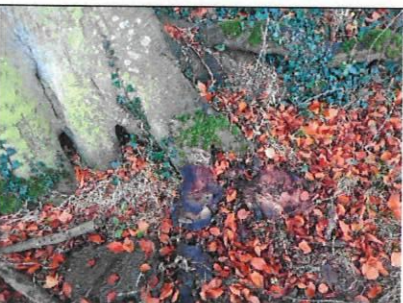
Meripilus giganteus fungal fruiting bodies on Beech tree T8

T	8	Fagus sylvatica (Beech)	M	21	1000	<10	Fair/Poor	Poor. Low vitality. <i>Meripilus giganteus</i> fruiting brackets at stem base indicating degraded anchorage and stability. Some sparseness of upper crown.	Not suited for long-term retention within a new development.	12	U
T	9	Fagus sylvatica (Beech)	M	21	1000	<10	Poor	Fair. Low vitality. Dieback in crown.	Monitor tree condition.	12	U
T	10	Fagus sylvatica (Beech)	OM	21	1000	<10	Poor	Bad. Significant basal decay. Very large old tear-out wound at base of main stem.	Not suited for long-term retention within a new development.	12	U

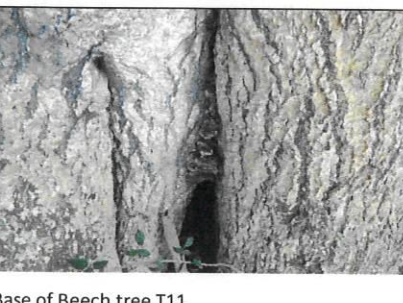
Base of Beech tree T11

Type	No.	Species	Age	Ht m	Dbh mm	ERC	Phys Cond	Structural Condition/Comments	Preliminary Recommendations	RPA m	Cat
T	11	Fagus sylvatica (Beech)	OM	22	1250	<10	Poor	Poor. Large specimen tree. <i>Ganoderma spp.</i> fungal fruiting bodies on stem indicating internal wood decay.	Not suited for long-term retention within a new development.	15	U
T	12	Fagus sylvatica (Beech)	M	21	1000	10+	Fair	Fair. Asymmetric form due to group competition.	No urgent works needed.	12	C2
T	13	Fagus sylvatica (Beech)	OM	21	1000	<10	Poor	Poor. Dieback in crown. <i>Armillaria spp.</i> Fungal fruiting bodies at stem base indicative of degraded roots and anchorage.	Monitor tree condition. Not suited for long-term retention within a new development.	12	U
T	14	Fagus sylvatica (Beech)	OM	10	1000	<10	Poor	Poor. Significant basal decay. Formerly large old tree that has suffered catastrophic failure of main stem at 4m in the past.	Not suited for long-term retention within a new development.	12	U

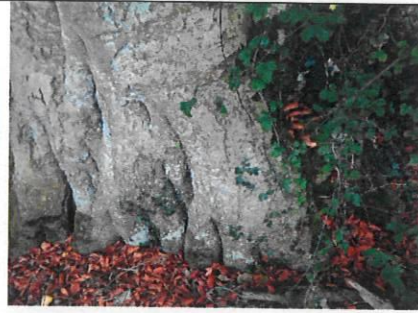
Armillaria spp. fungi at base of Beech tree T13

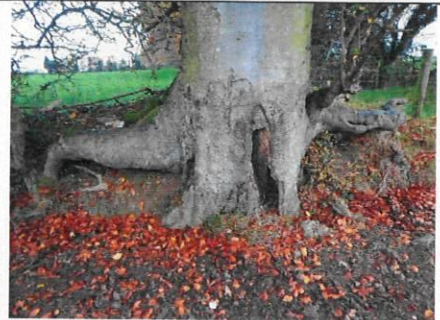
Base of Beech tree T16

T	15	Quercus robur (Common Oak)	M	17	800	<10	Poor	Poor. Significant dieback in crown.	Monitor tree condition. Not suited for long-term retention within a new development.	9.6	U
T	16	Fagus sylvatica (Beech)	OM	20	1000	<10	Poor	Poor. Significant basal decay.	Not suited for long-term retention within a new development.	12	U
T	17	Fagus sylvatica (Beech)	M	21	1250	10+	Fair	Fair. Large specimen tree.	Monitor tree condition.	15	C2
T	18	Fagus sylvatica (Beech)	OM	21	1000	<10	Poor	Poor. Old tear-out wound on main stem. <i>Meripilus giganteus</i> fruiting brackets at stem base indicating degraded anchorage and stability. Sparse crown.	Not suited for long-term retention within a new development.	12	U
T	19	Quercus robur (Common Oak)	M	18	850	10+	Poor	Fair. Some dieback of upper crown.	Monitor tree condition.	10.2	C2
T	20	Quercus robur (Common Oak)	M	18	850	10+	Poor/Fair	Fair. Some minor dieback of upper crown.	Monitor tree condition.	10.2	C2

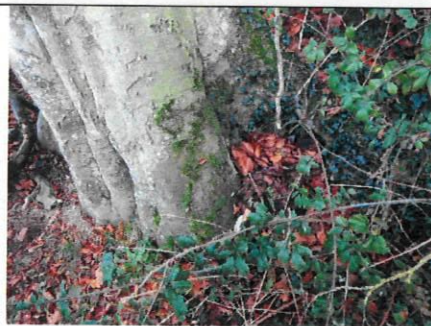
Meripilus giganteus fruiting bodies on Beech T18

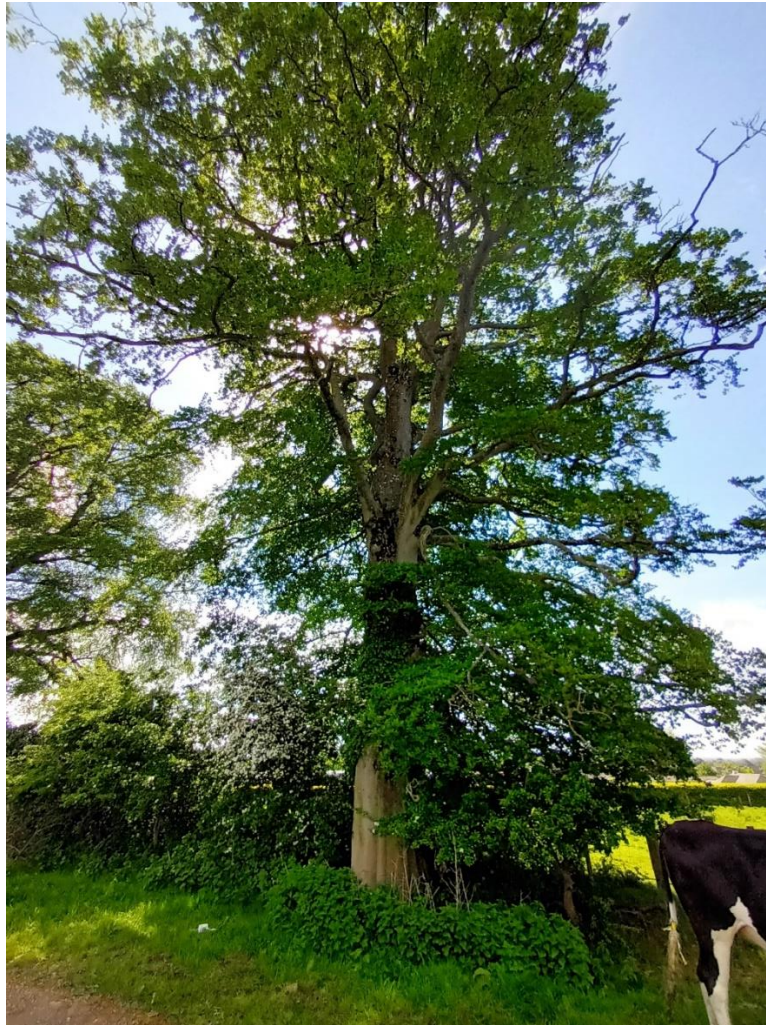
Fagus sylvatica (beech) Tree 0601

2. Roots & Surrounding Ground		Heavily compacted stone lane 2-3m to the north of the tree over the RPA. Ground somewhat compacted from livestock around the base of the tree and grass covered.						
Cracking, heave, compaction

7. Main Branches		Split hanging branch on the north side						
Biotic /abiotic factors, deadwood, structural integrity								
8. Twigs & Leaves		Good, full canopy with good leaf cover						
Biotic/abiotic factors, size, colour, density								
Work required: <ul style="list-style-type: none"> - Remove the stock proof fence - Investigate decay fungus 					Priority (timescales)		Medium	
					Re-inspection		Annual	
					Today's date		19/05/22

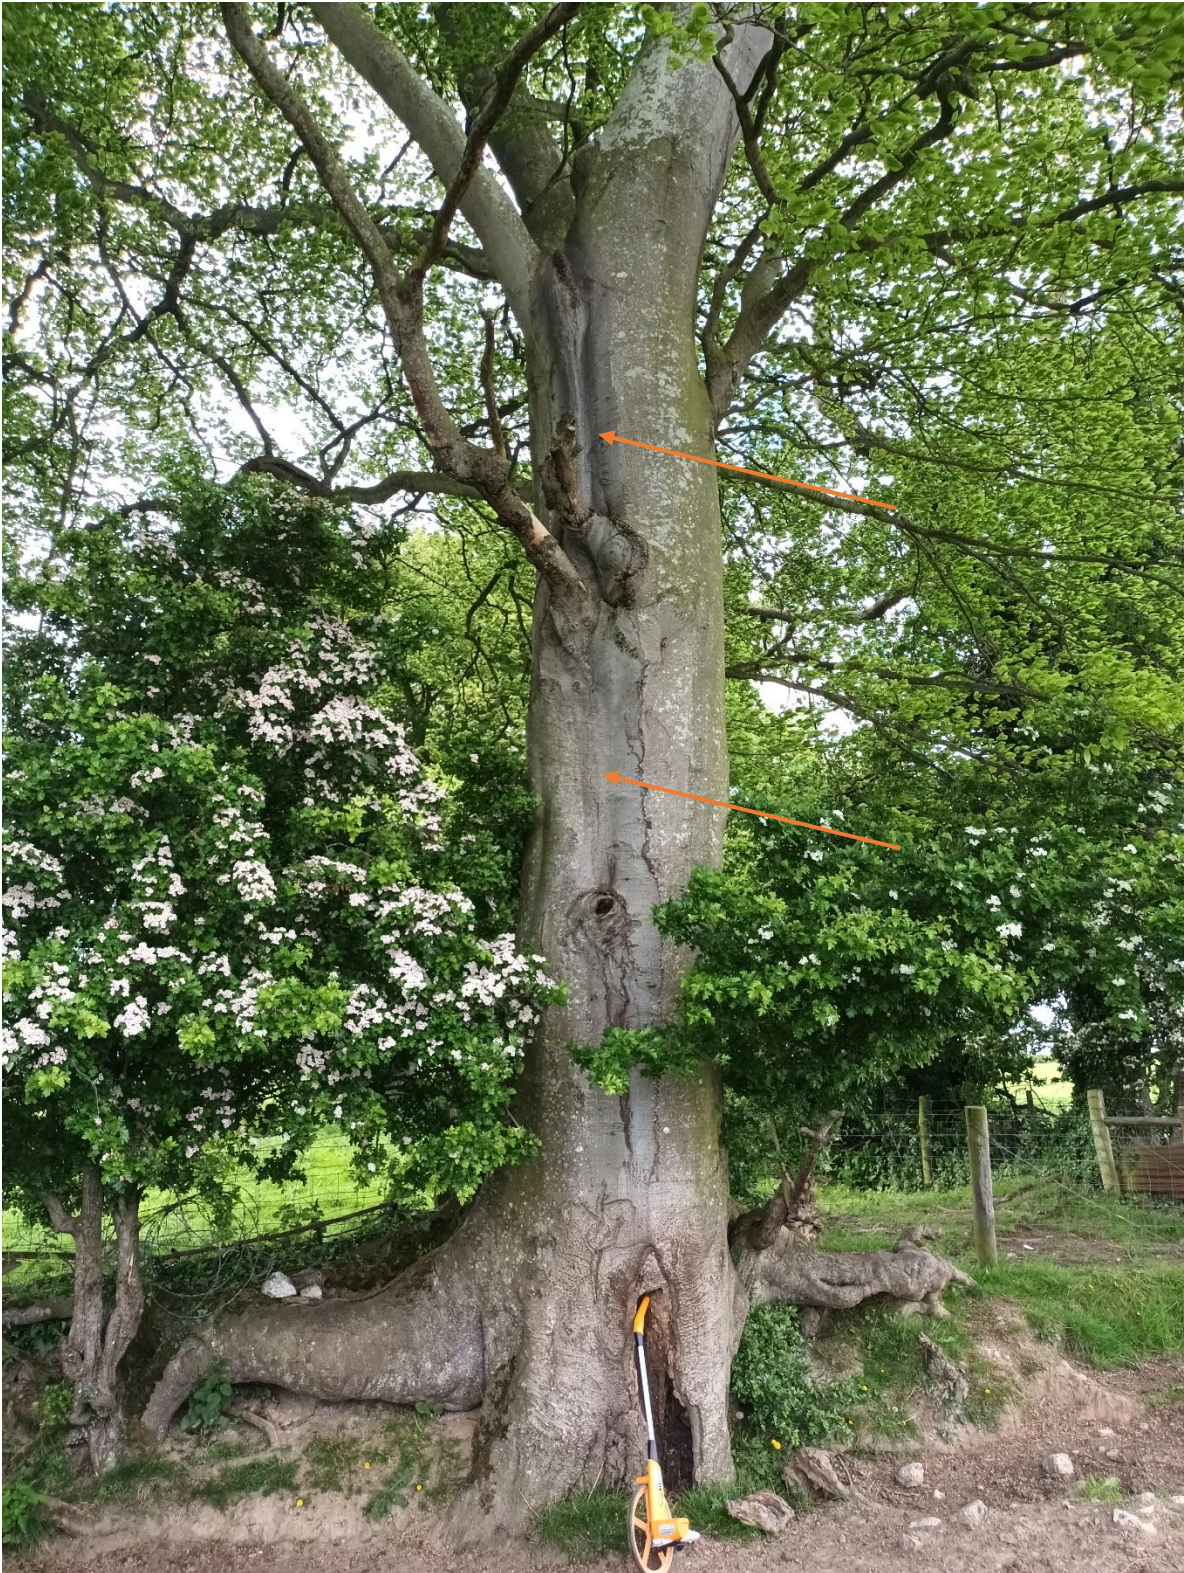
Lower main stem of *Fagus sylvatica* (beech) 0616

2. Roots & Surrounding Ground		Ground to the east and west compacted from livestock. No visual signs of heaving or cracking.						
Cracking, heave, compaction

3. Buttresses		Roots visible along the embankment. Root flair good and some flutes in the main stem at the root flair. Some minor splitting of the root flair also.						
Decay, physical damage, structural integrity

4. Trunk		Straight main stem up to 5m with some ivy cover						
biotic/abiotic damage, exudates, structural integrity, slenderness								
5. Main Union		Main union of 2 stems at 5m high and separates again into 2 on the north ascending stem						
decay, other plants, exudates, structural integrity

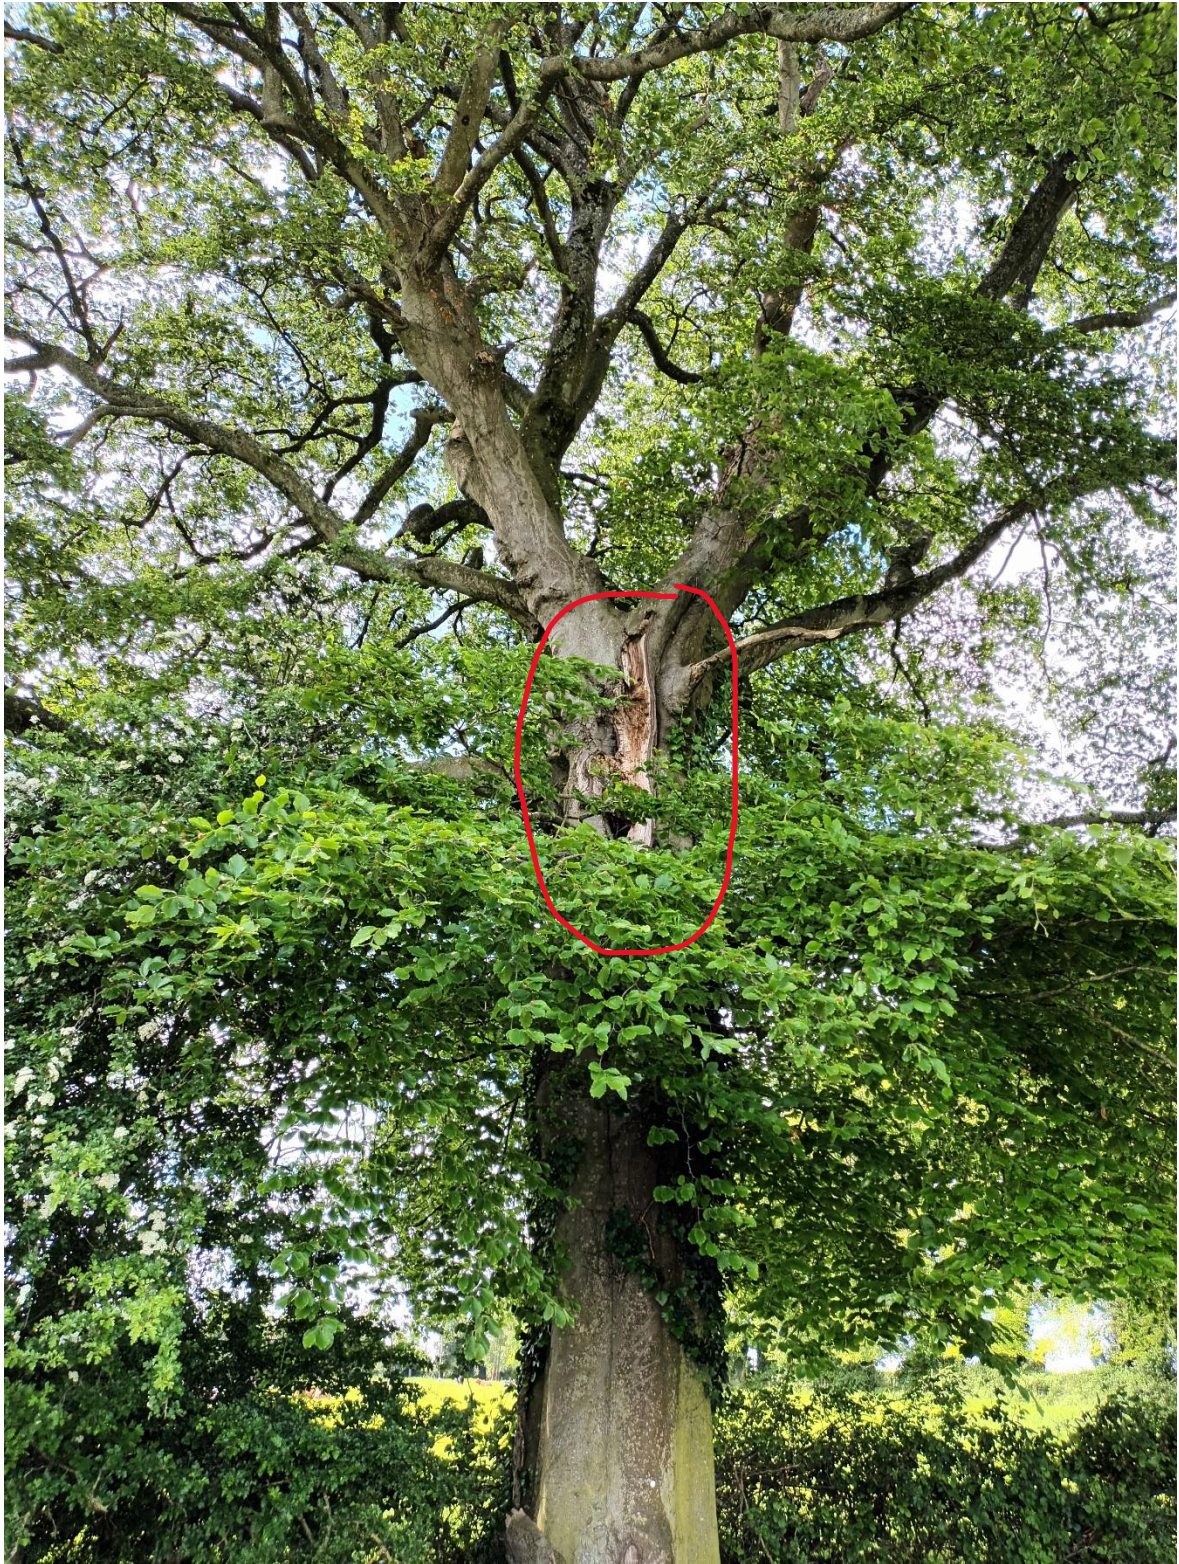
2. Roots & Surrounding Ground		Ground to the east and west compacted from livestock. No visual signs of heaving or cracking. Significant deadwood on the ground at the eastern base of the tree.						
Cracking, heave, compaction

3. Buttresses		Roots visible along the embankment. Root flair good and some flutes in the main stem at the root flair.						
Decay, physical damage, structural integrity

4. Trunk		Large decaying tear on the east where a main branch has ripped away from the main stem. Tear from approx. 5m up to 7.5m vertically on the east of the main stem.						
biotic/abiotic damage, exudates, structural integrity, slenderness

5. Main Union		Splits into multiple ascending limbs from 8m high						
decay, other plants, exudates, structural integrity								
6. Primary Ascending Stems		Splits into multiple ascending limbs from 8m high						
Biotic/abiotic factors, deadwood, structural integrity

7. Main Branches		Possible decay on the North-east ascending stem and a dead branch under this ascending limb.						
Biotic /abiotic factors, deadwood, structural integrity

Main stem of *Fagus sylvatica* (beech) 0618

8. Twigs & Leaves		Generally goo leaf cover						
Biotic/abiotic factors, size, colour, density								
Work required: <ul style="list-style-type: none"> - Monitor the decay and deadwood - Remove the agricultural wire 					Priority (timescales)	Medium		
					Re-inspection	Annual		
					Today's date	19/05/22
