Monasterevin Bridge Rehabilitation Works

Preliminary Remedial Works Report

Client: Kildare County Council

Project: K424

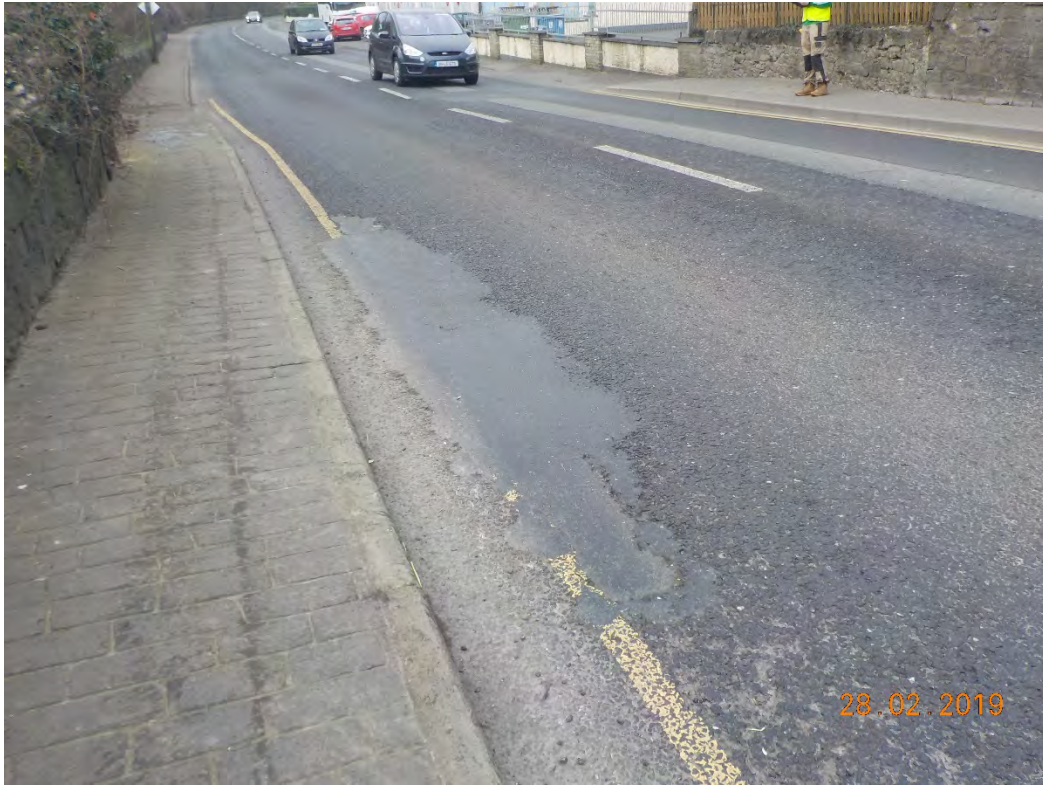
- i. Major patch repair works to Surface, see photograph 3-1, 3.2 and 3.3

Photograph 3-1: Bridge Surface

- i. Road to be planned and resurfaced, see photograph 3.4

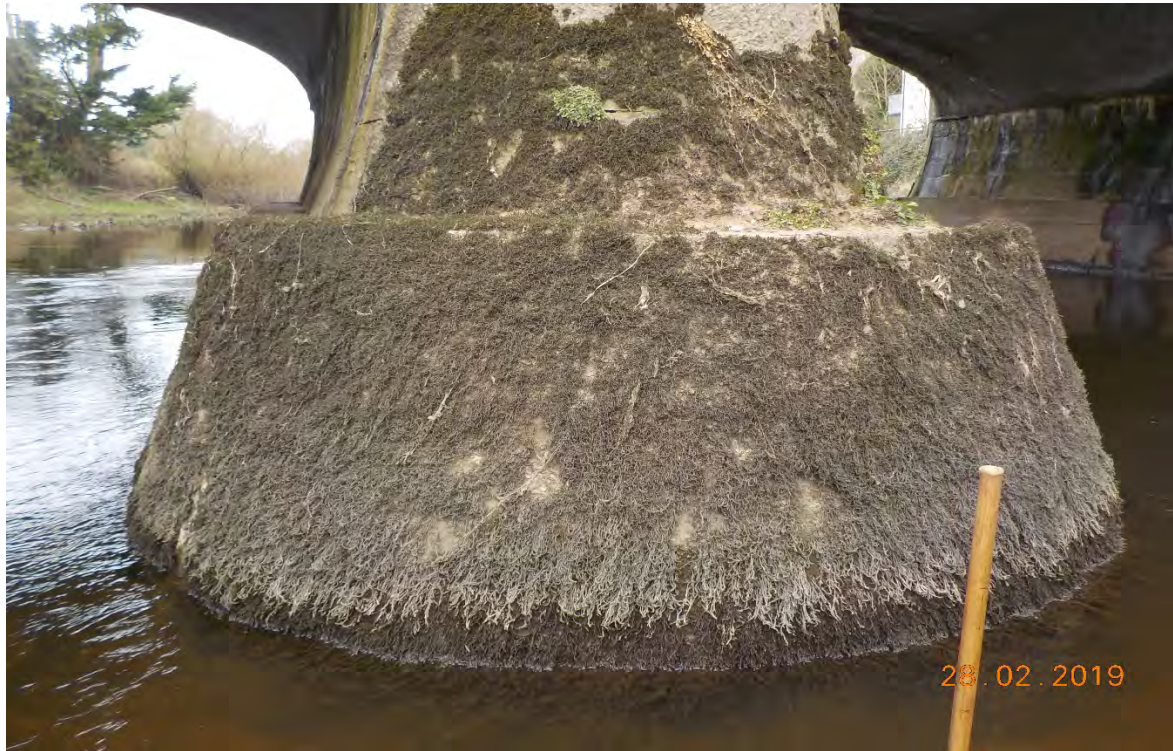
- i. Vegetation growing around Pier 1, See photograph 3.53
- ii. Pier 2 upstream cutwater undermined and separating from bridge pier, See photograph 3.54 and 3.55
- iii. Vegetation growing on downstream Pier 2, See photograph 3.57 and 3.58
- iv. Scouring occurring at upstream cutwater Pier 3, See photograph 3.66, 3.67 and 3.68
- v. Vegetation growing on downstream Pier 4, See photograph 3.62
- vi. Vegetation growing on upstream Pier 4 and a small crack commencing in the upstream cutwater, See photographs 3.69, 3.70 and 3.71

Photograph 3-57: Downstream Pier 2

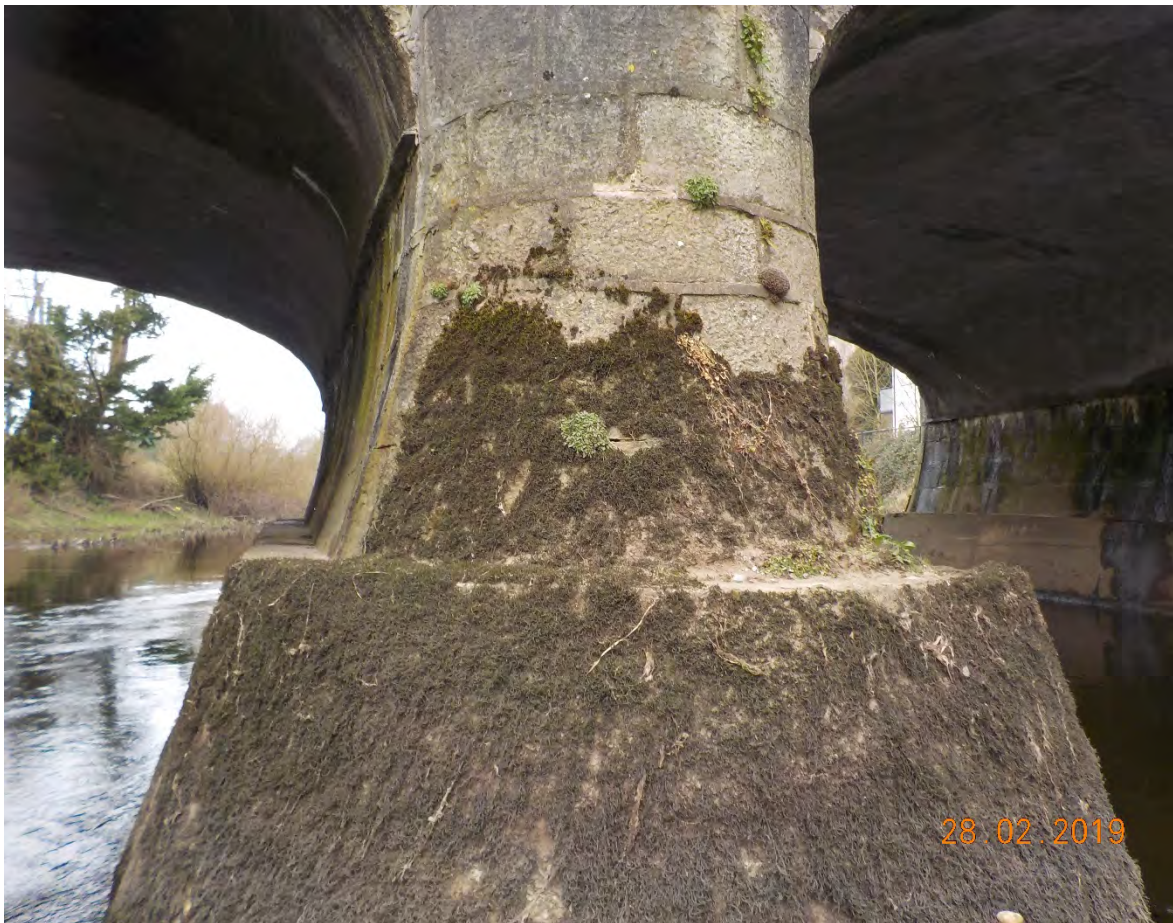
Photograph 3-58: Downstream Pier 2

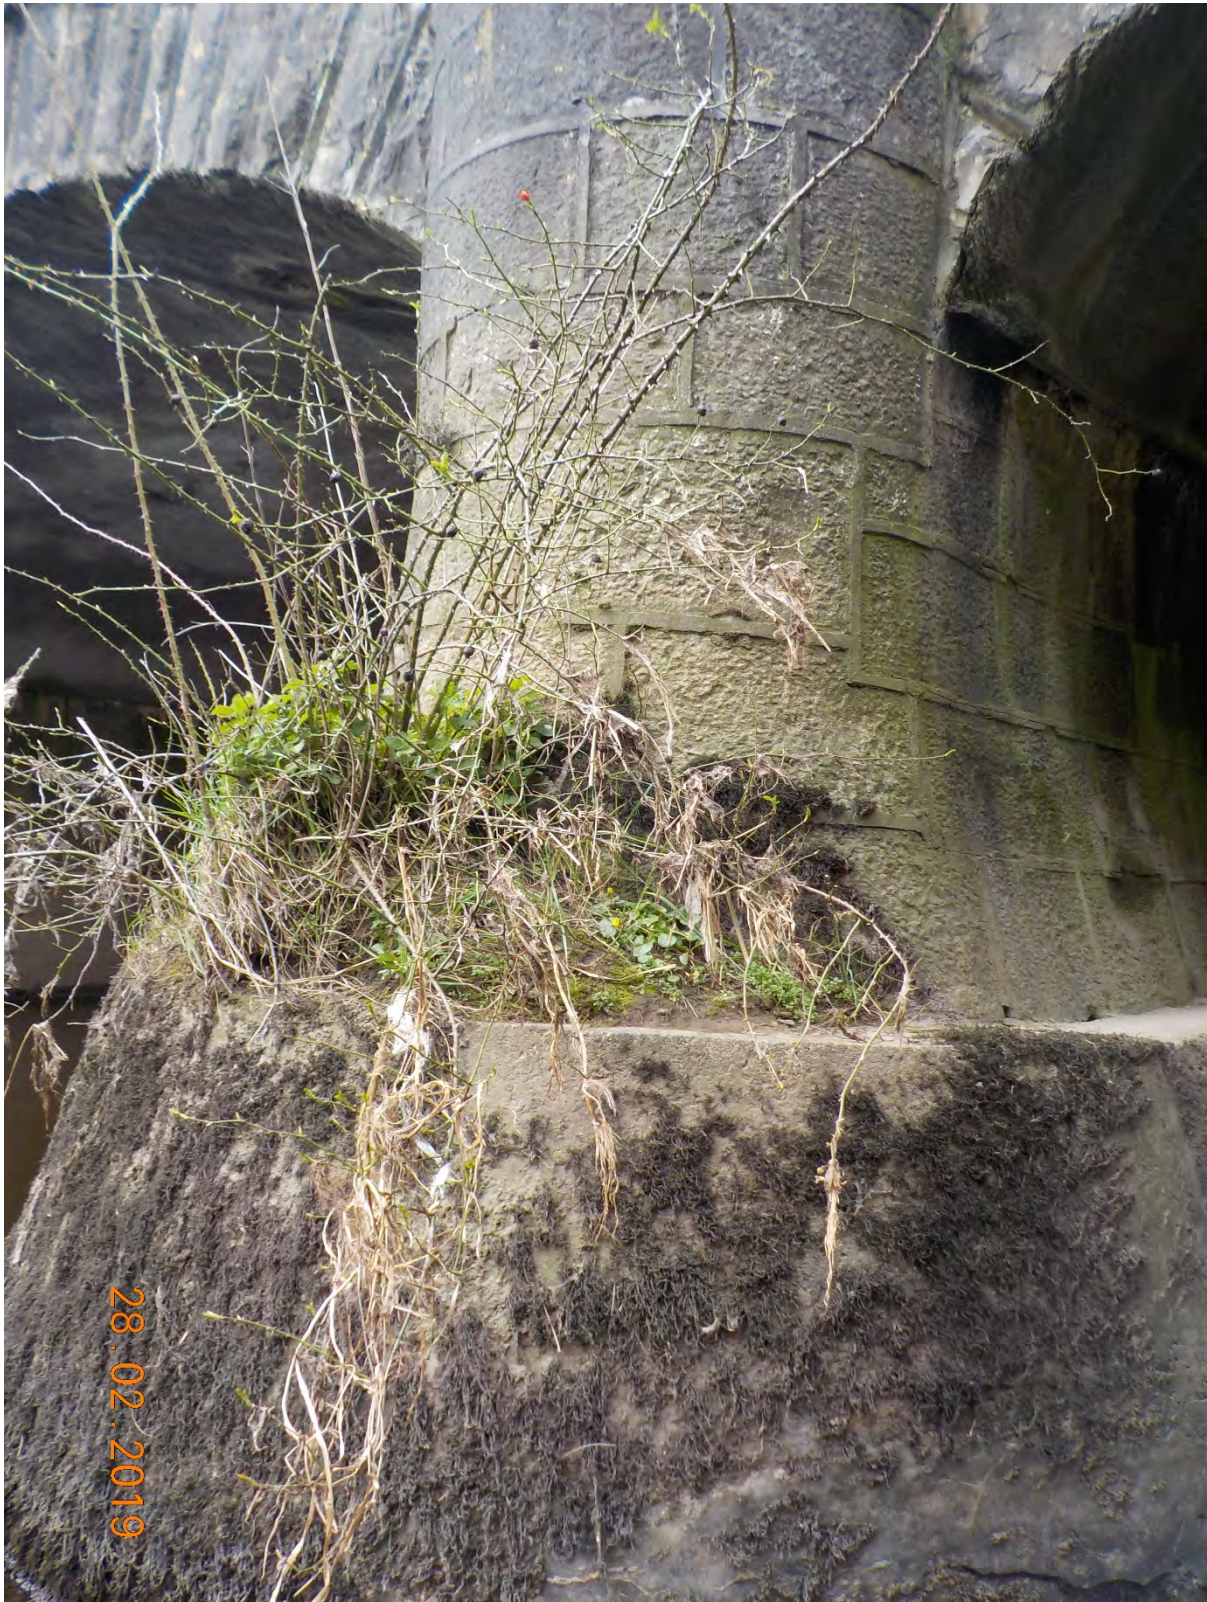
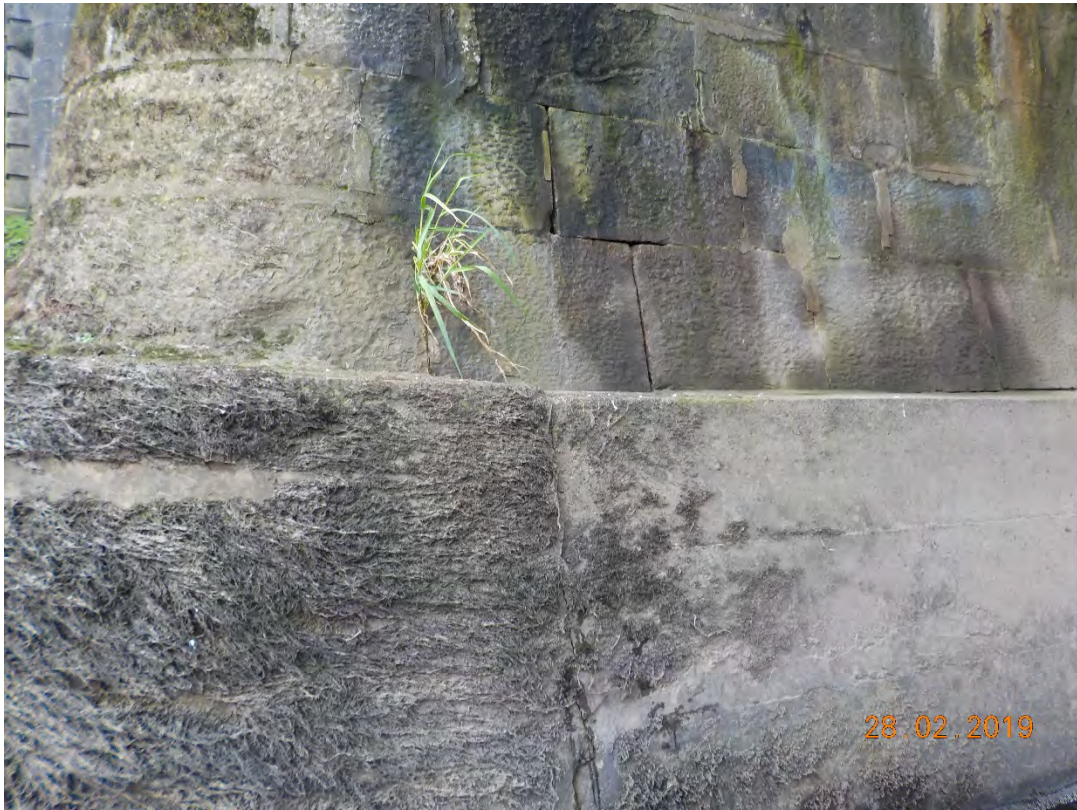
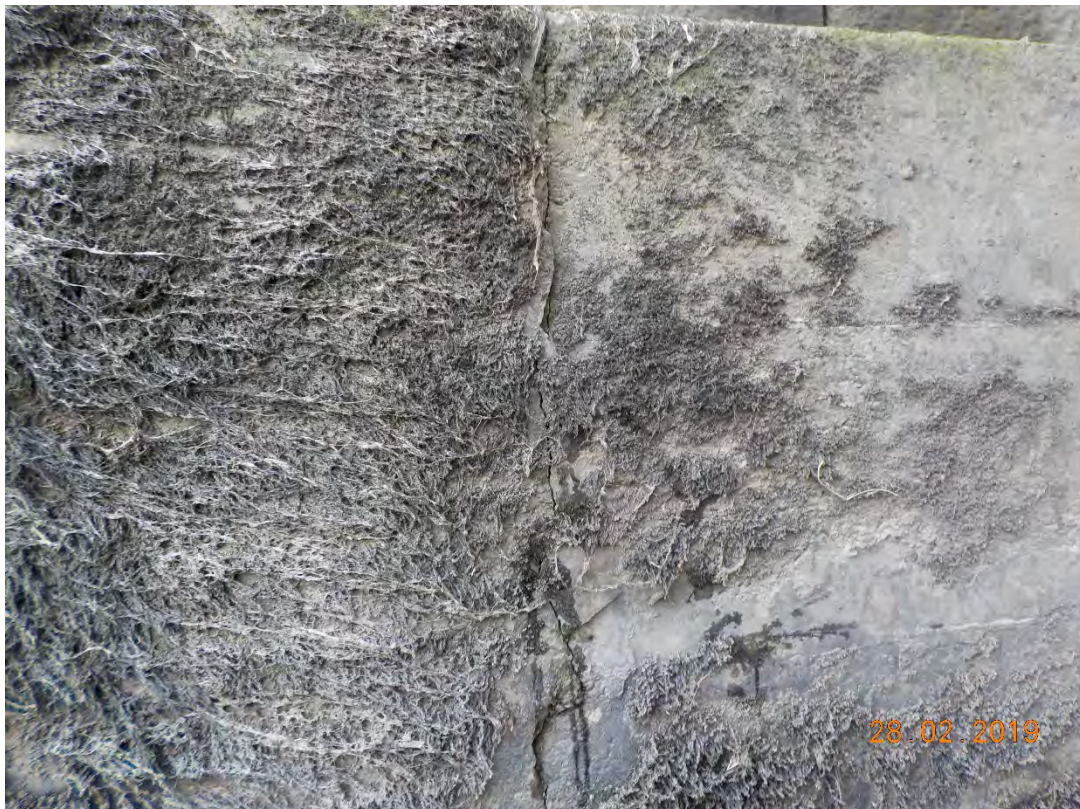
Photograph 3-69: Pier 4 - Upstream

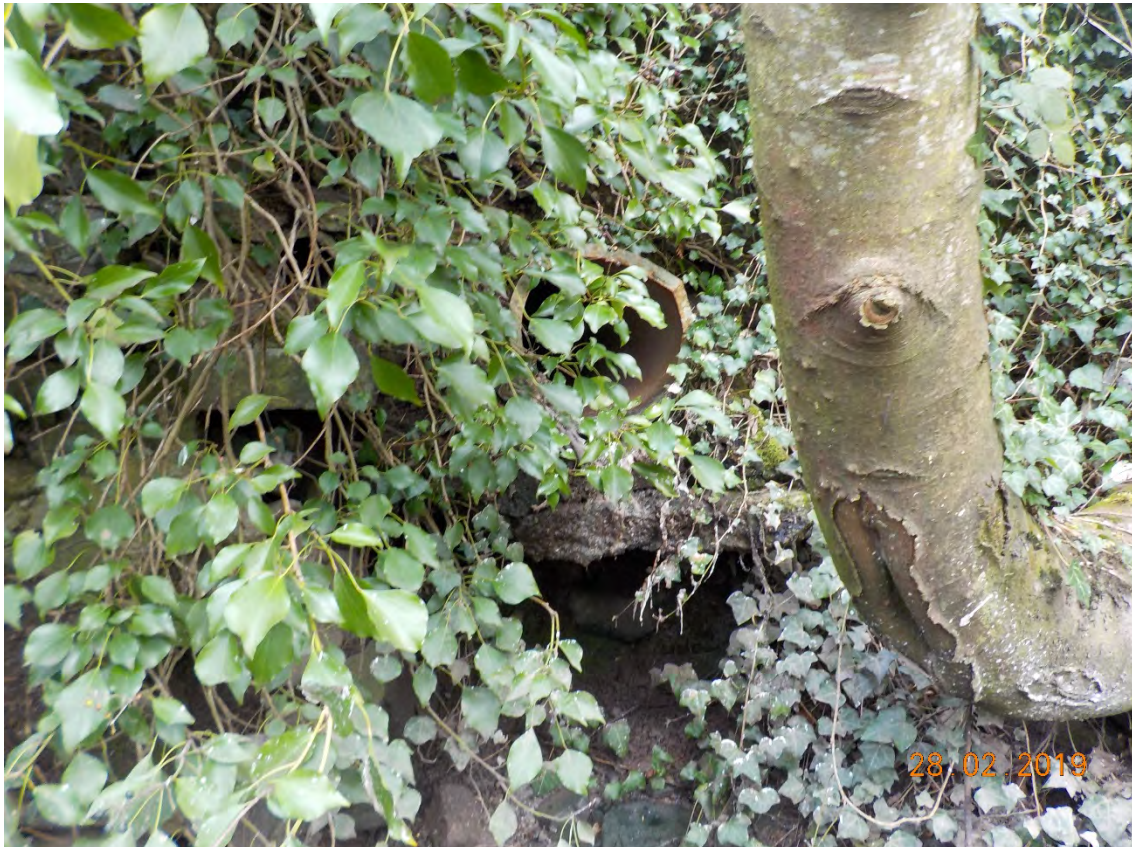
- i. Heavy overgrowth on downstream west left embankment causing a blockage for accessing the embankment, See photograph 3.35, 3.36 and 3.37
- ii. Retaining wall failing on downstream west left embankment, See photograph 3.38 and 3.77
- iii. Tree's overgrowing on downstream west left embankment, See photograph 3.39 and 3.40
- iv. Tree's and overgrowth growing wild on downstream east embankment, See photographs 3.41, 3.42 and 3.43
- v. Outfall pipe has collapsed on downstream left embankment, See photographs 3.78 and 3.79

Photograph 3-79: Outfall
